Lake Opening – Ross V

History of level management

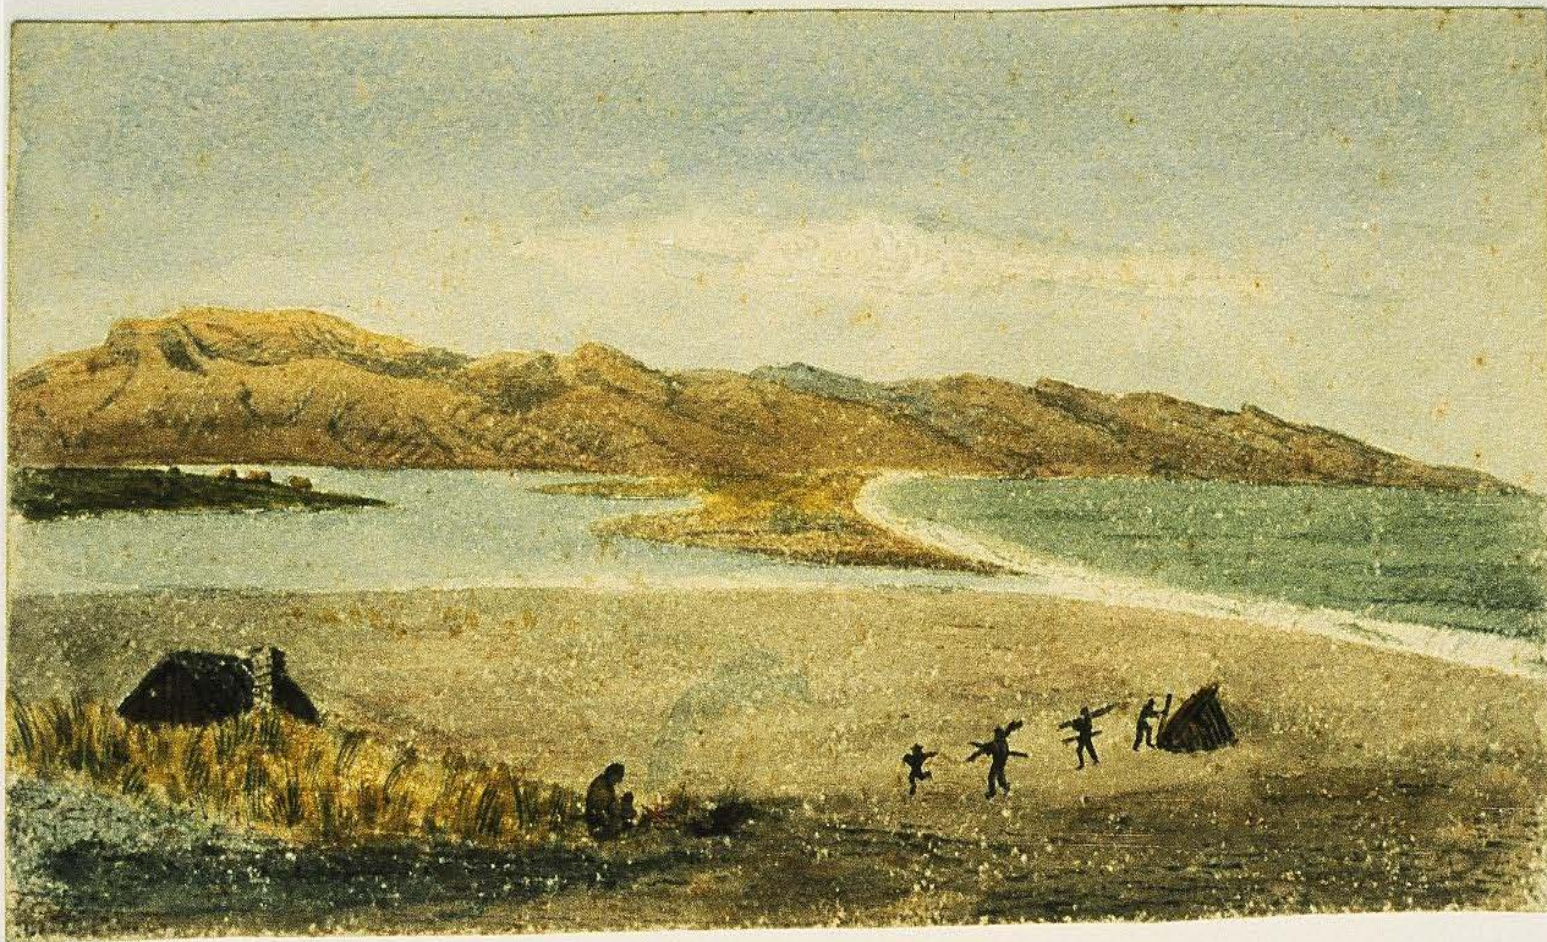
Figure 1.2 Historic opening 1886

Lake Ellesmere. Mount Herbert. Banks Peninsula 1886

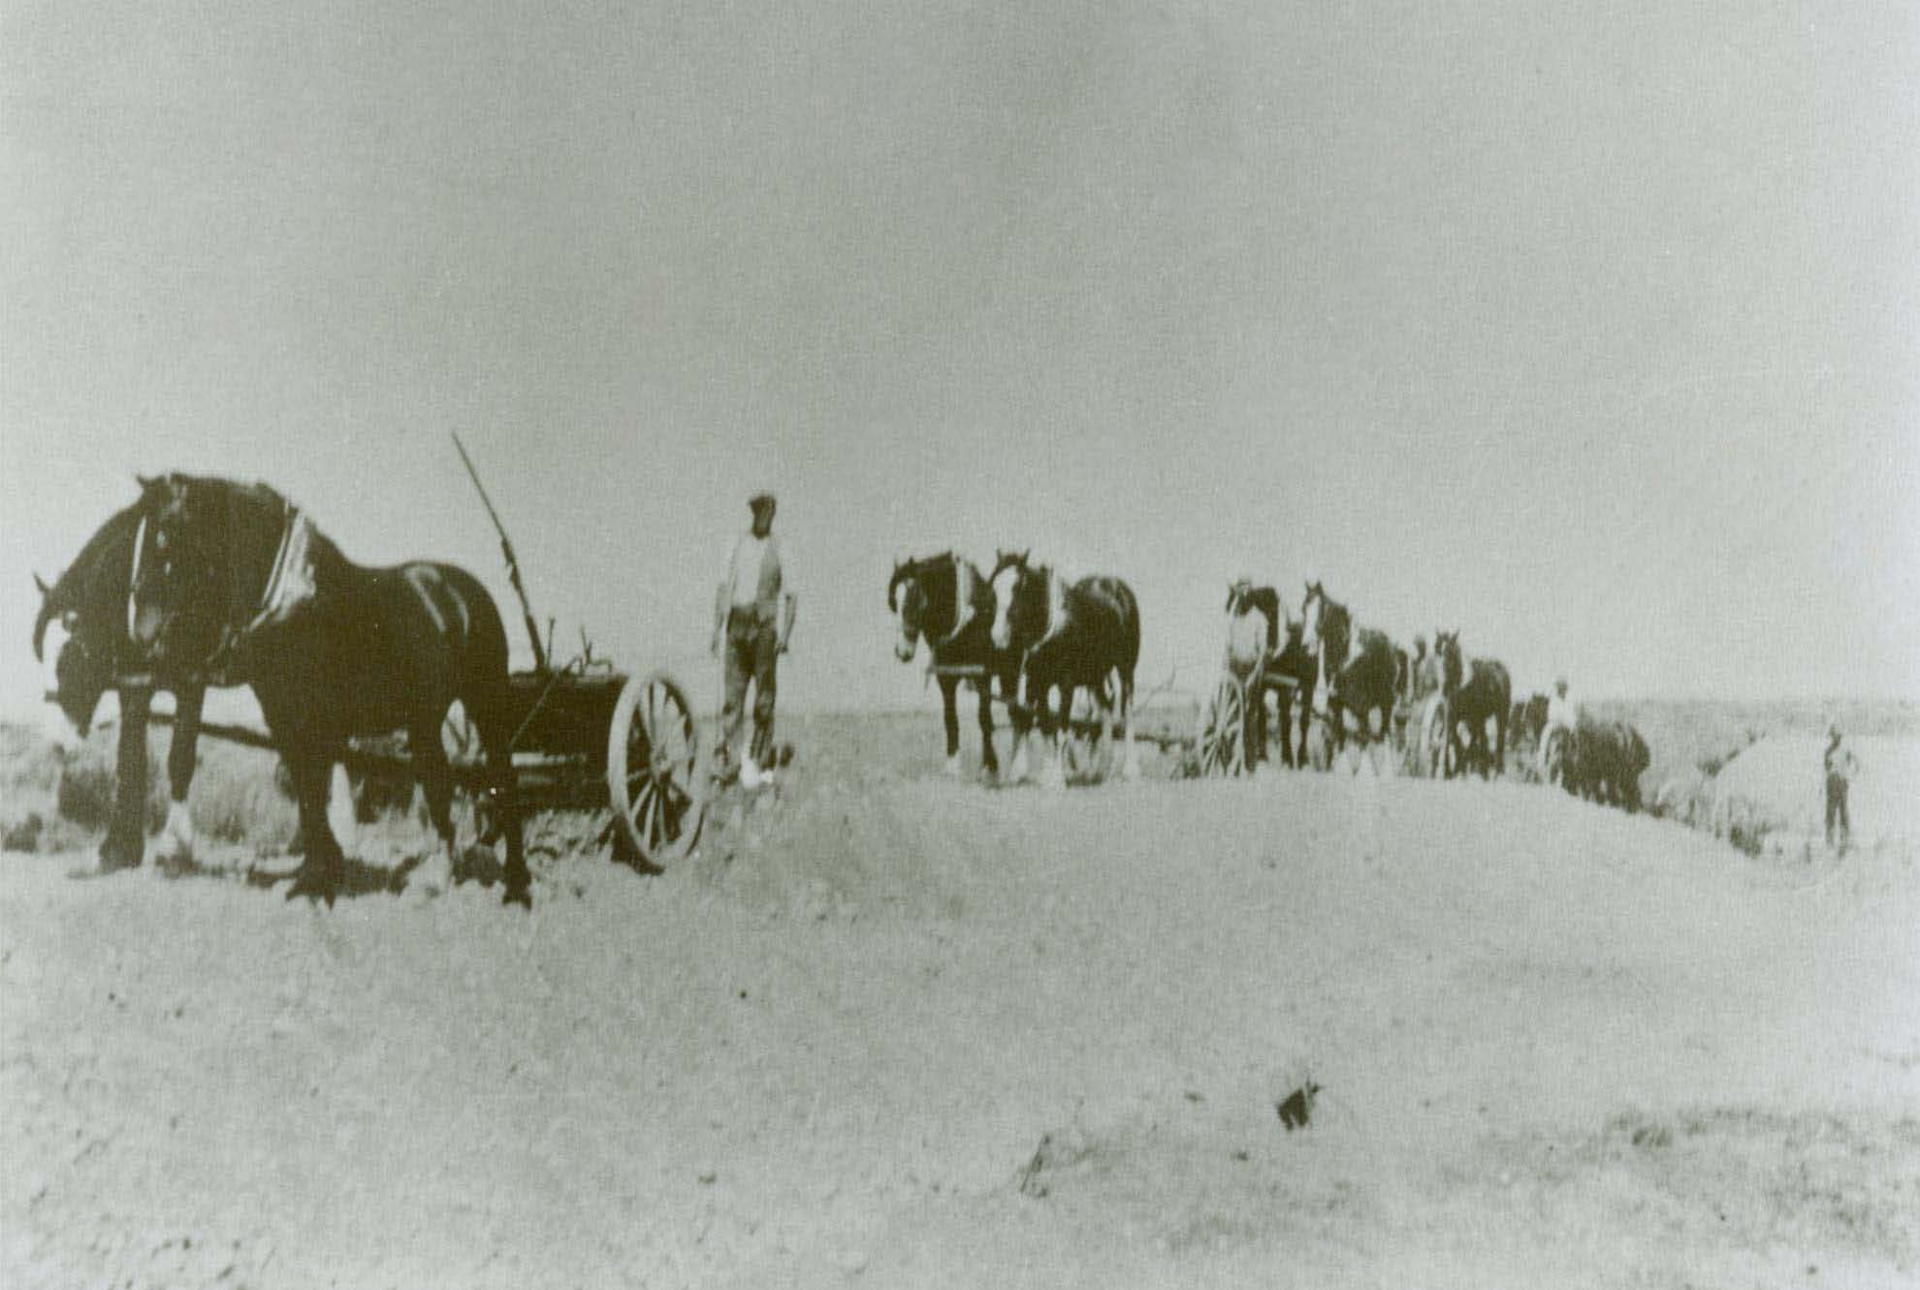
~ 1880's Horse-drawn scoops

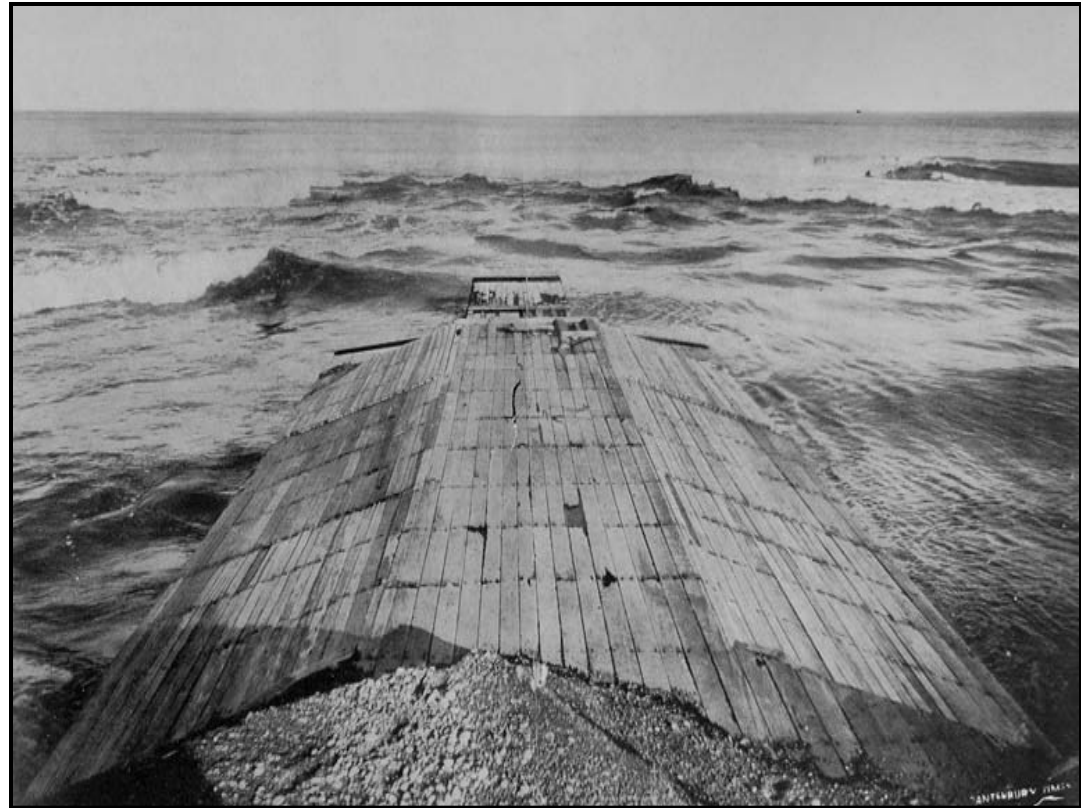
Permanent Opening Structure

- Culvert type structure
- Higher lake level
- Utilised greater head to scour out gravel
- Installed in 1904 but destroyed within 7 months
- Redesigned and upgraded in 1908
- Destroyed by successive storms in 1925
- Failed to alleviate problems associated with fluctuating lake levels

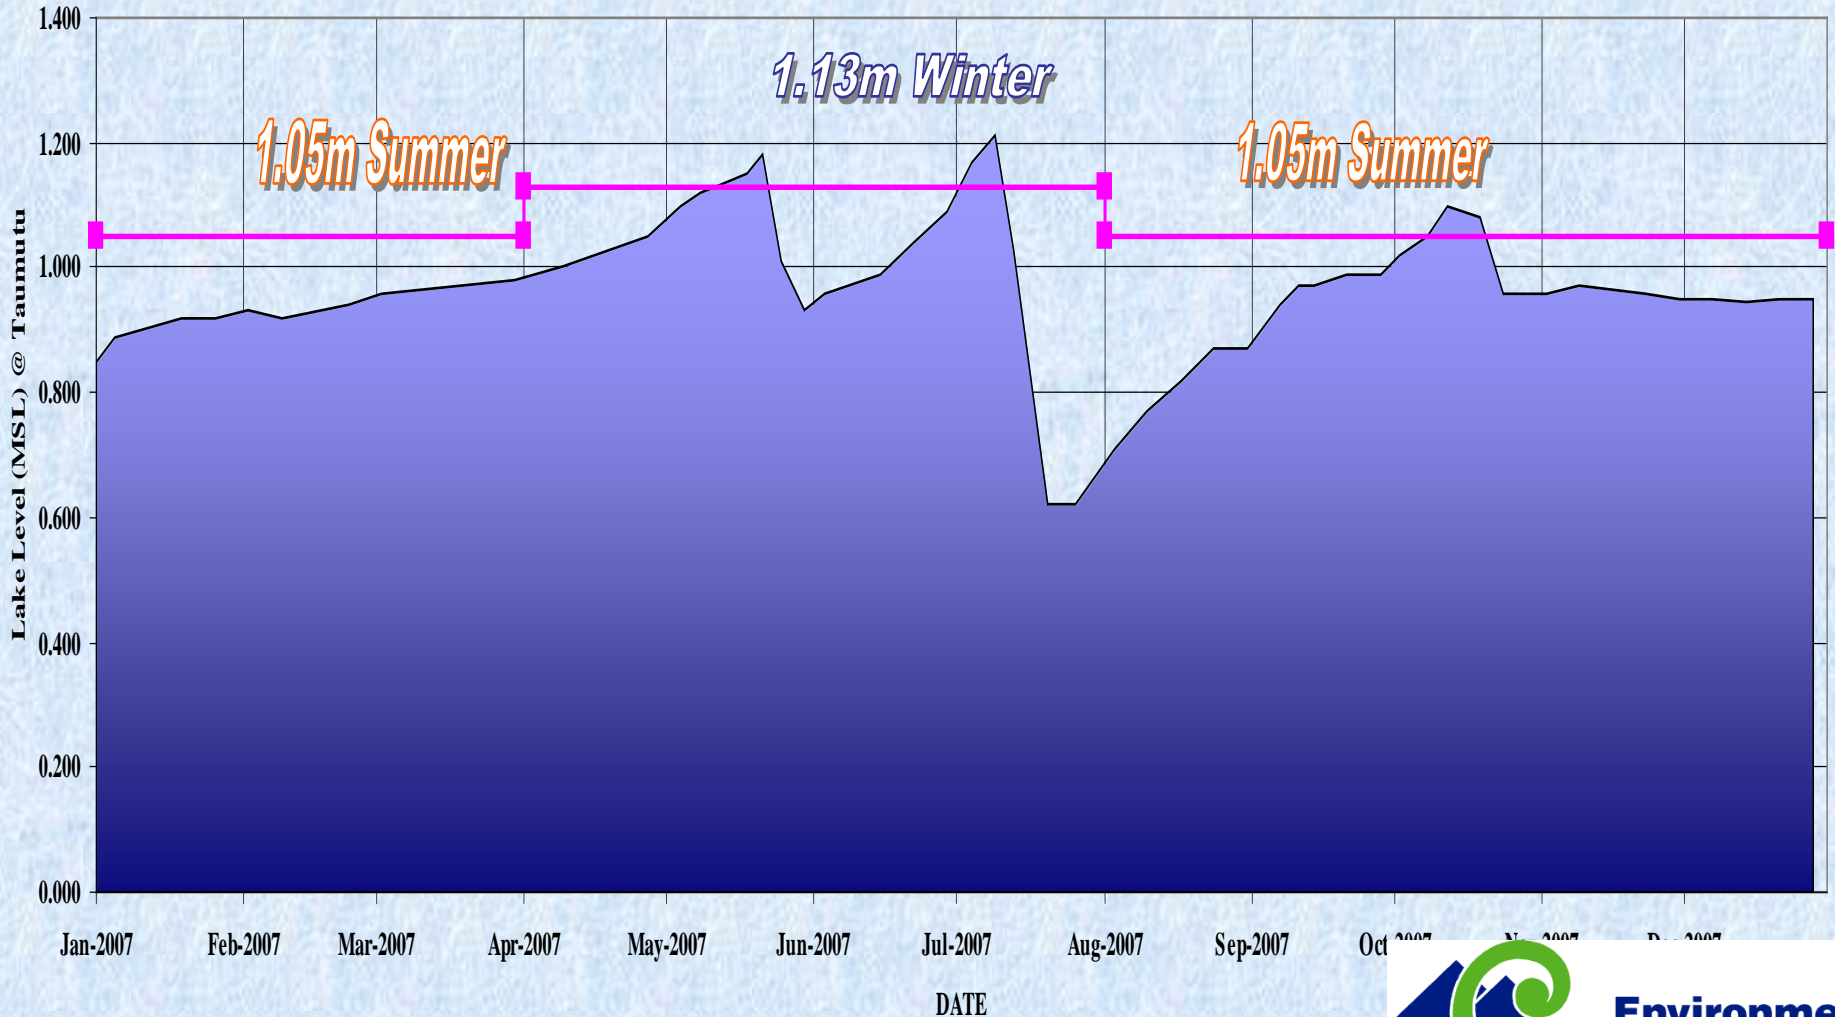
Lake Ellesmere Level
(calm day recordings below opening levels)
