# Update on water quality of Lake Ellesmere/Te Waihora

Shirley Hayward  
DairyNZ

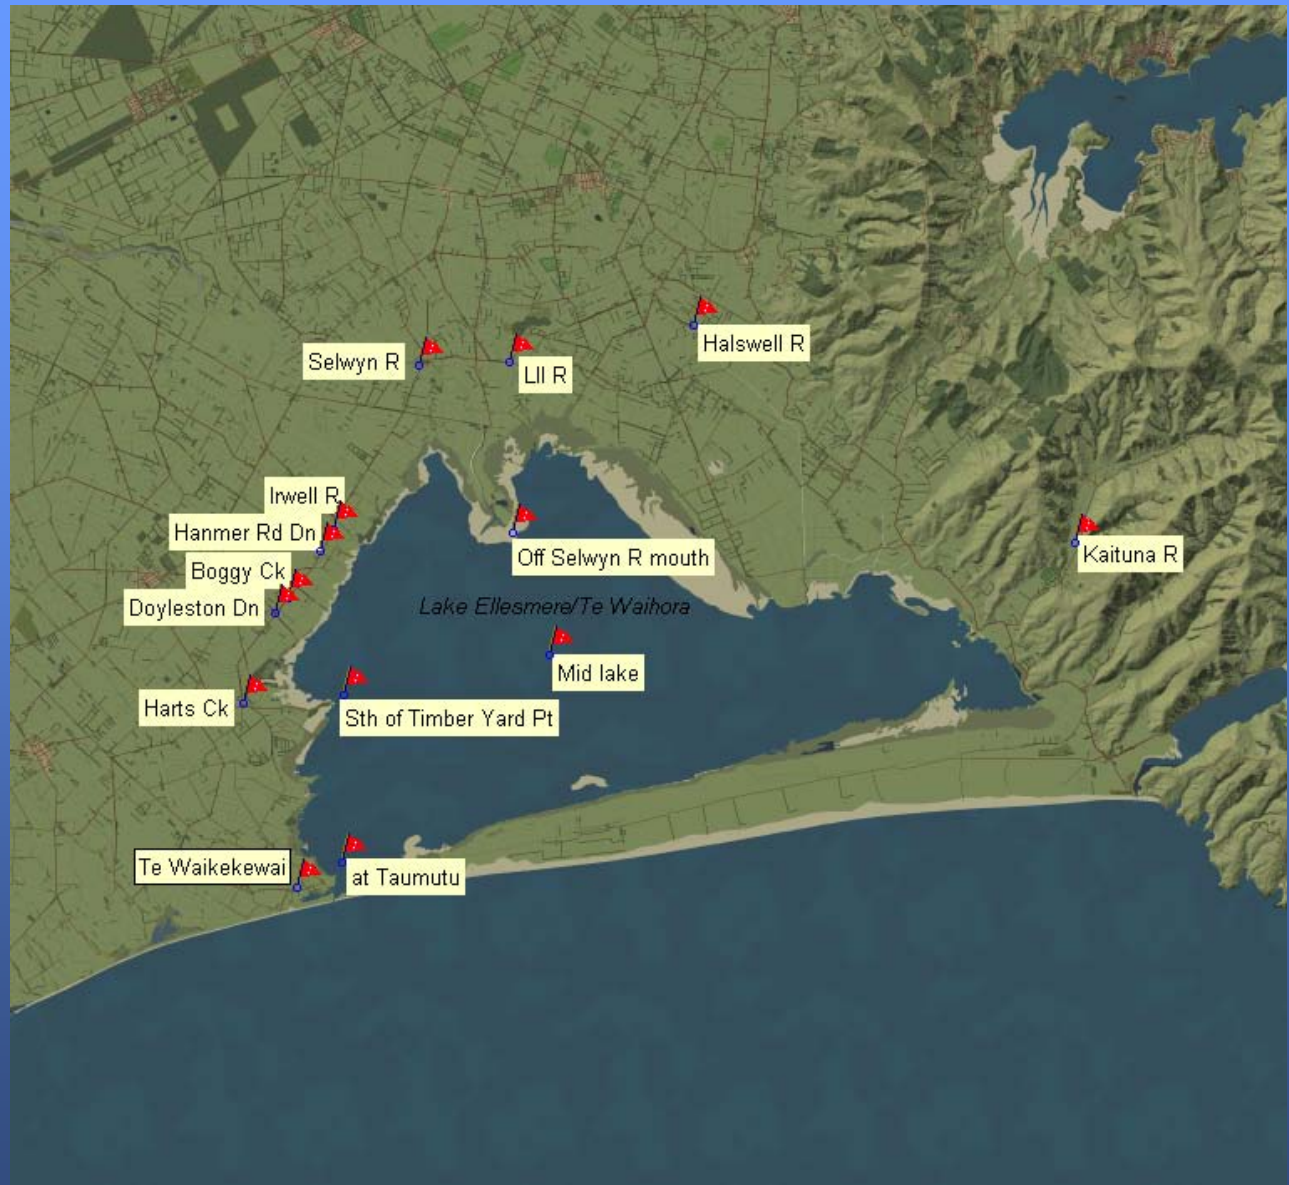
# Current water quality monitoring programme

Monthly sampling

Started 1992

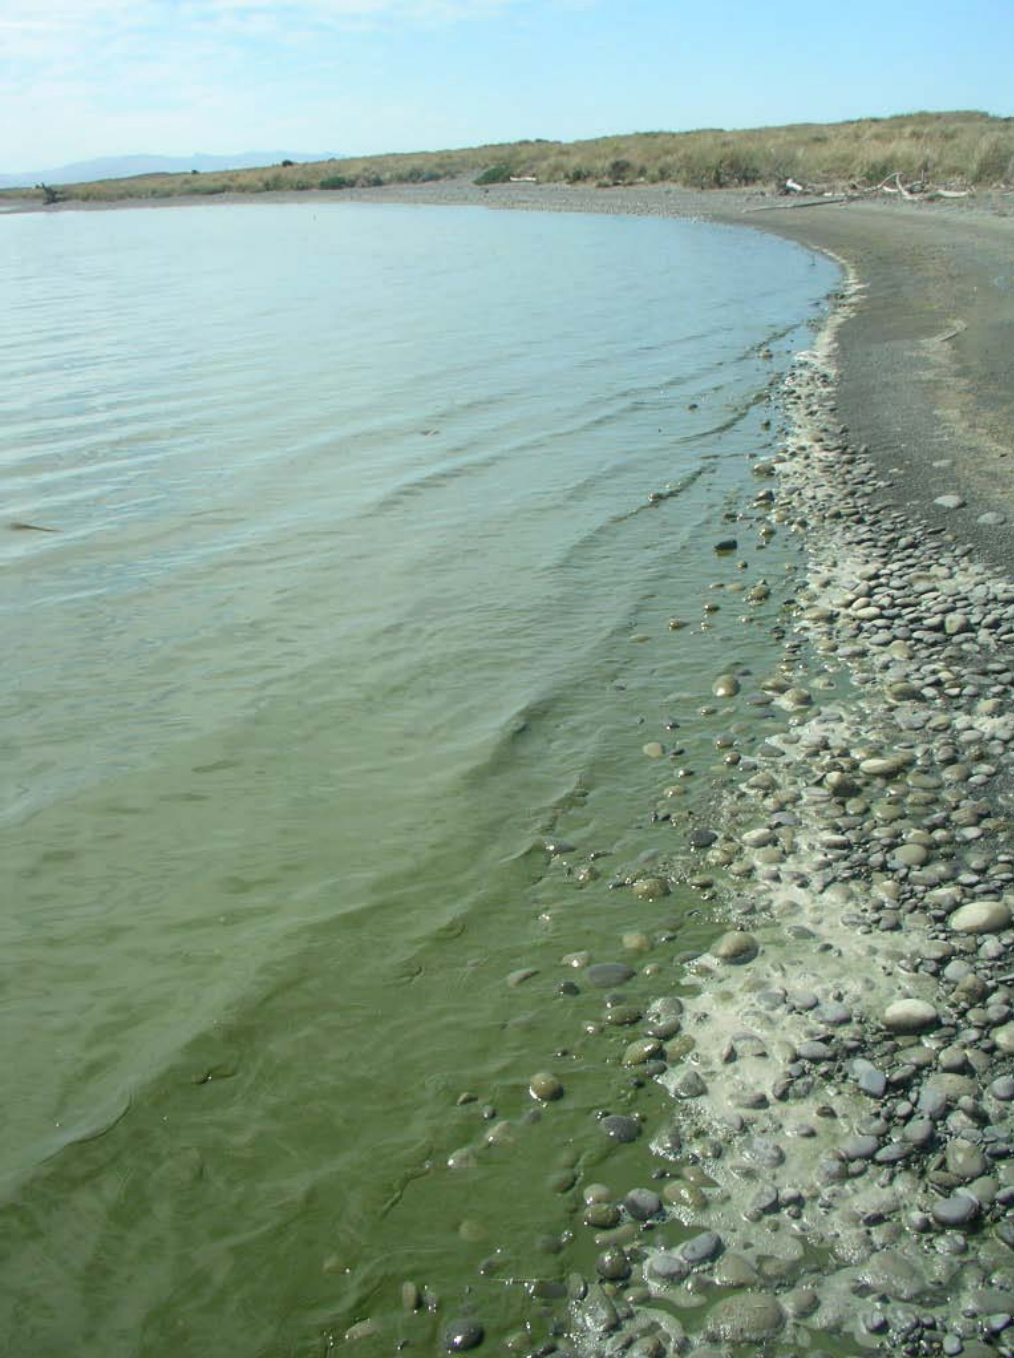
## Bloom of *Nodularia* February 2009

Health warnings  
notified and multiple  
signs placed around  
the lake

Warnings remained  
in place for several  
months

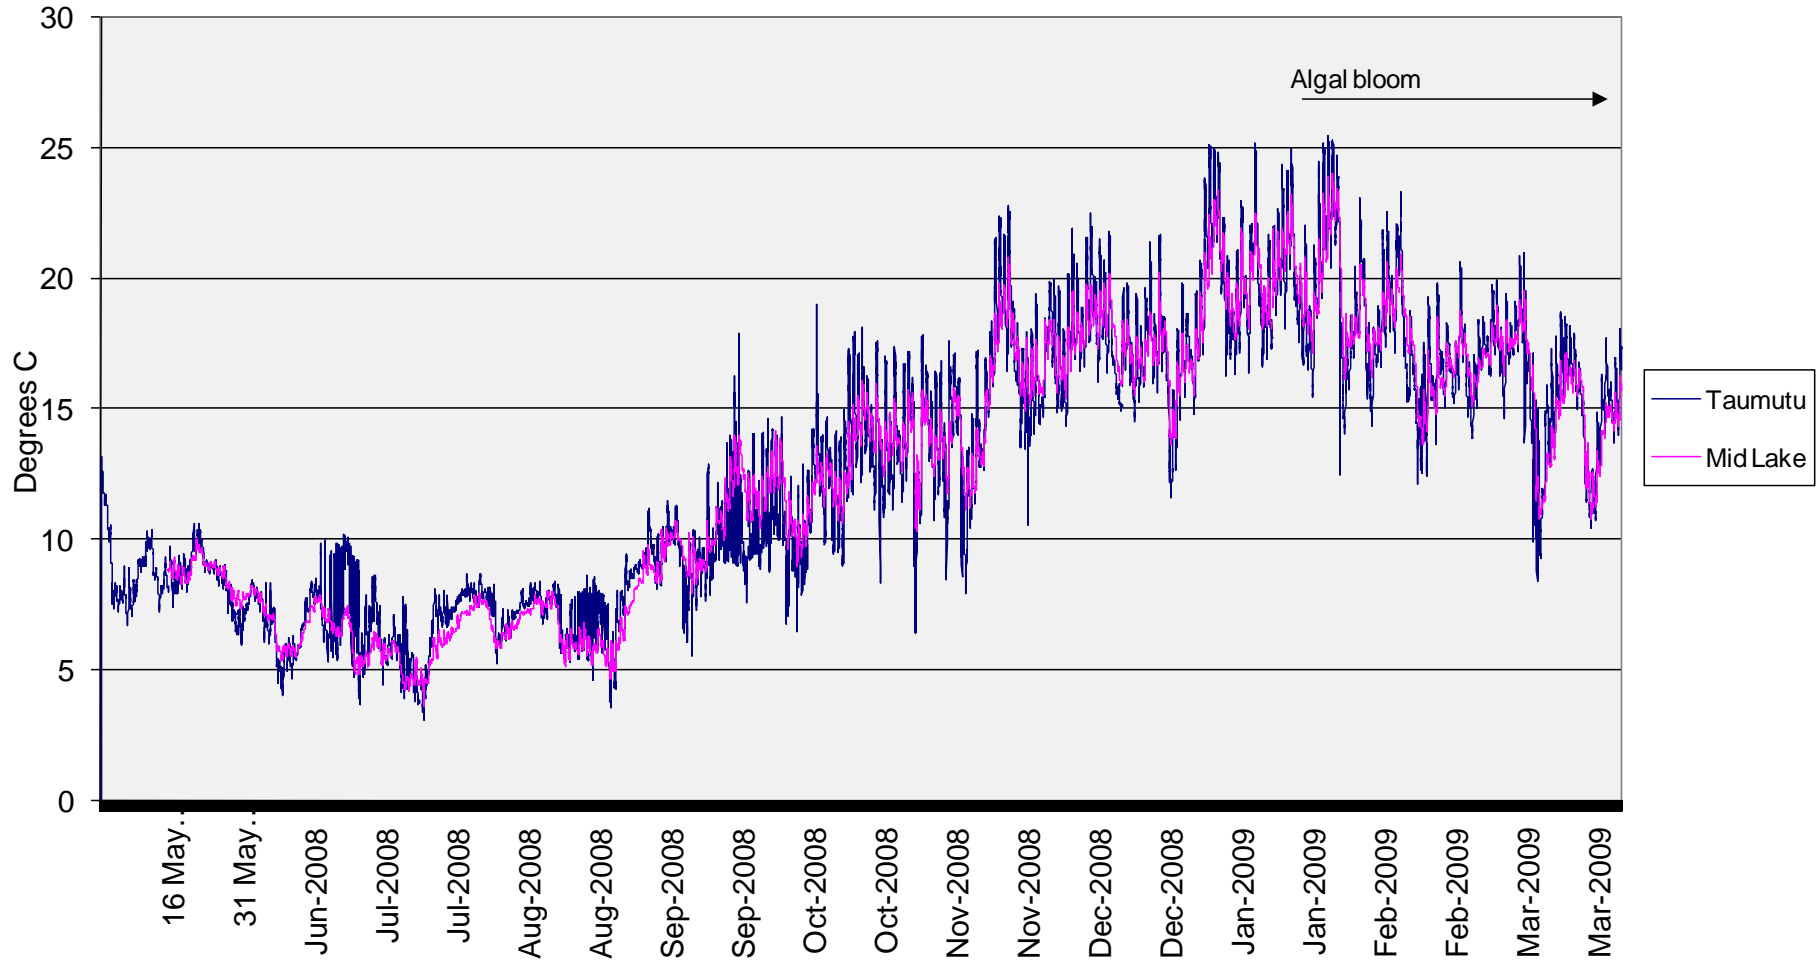
# Lake temperature

Lake Ellesmere/Te Waihora - continuous recorder data - Temperature

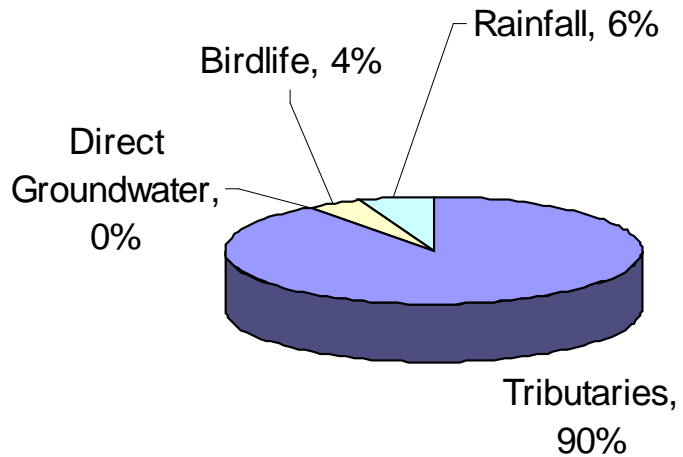
## Total phosphorus load

# Nutrients inputs

Nutrient inputs to Te Waihora (flow x conc.) - decreasing

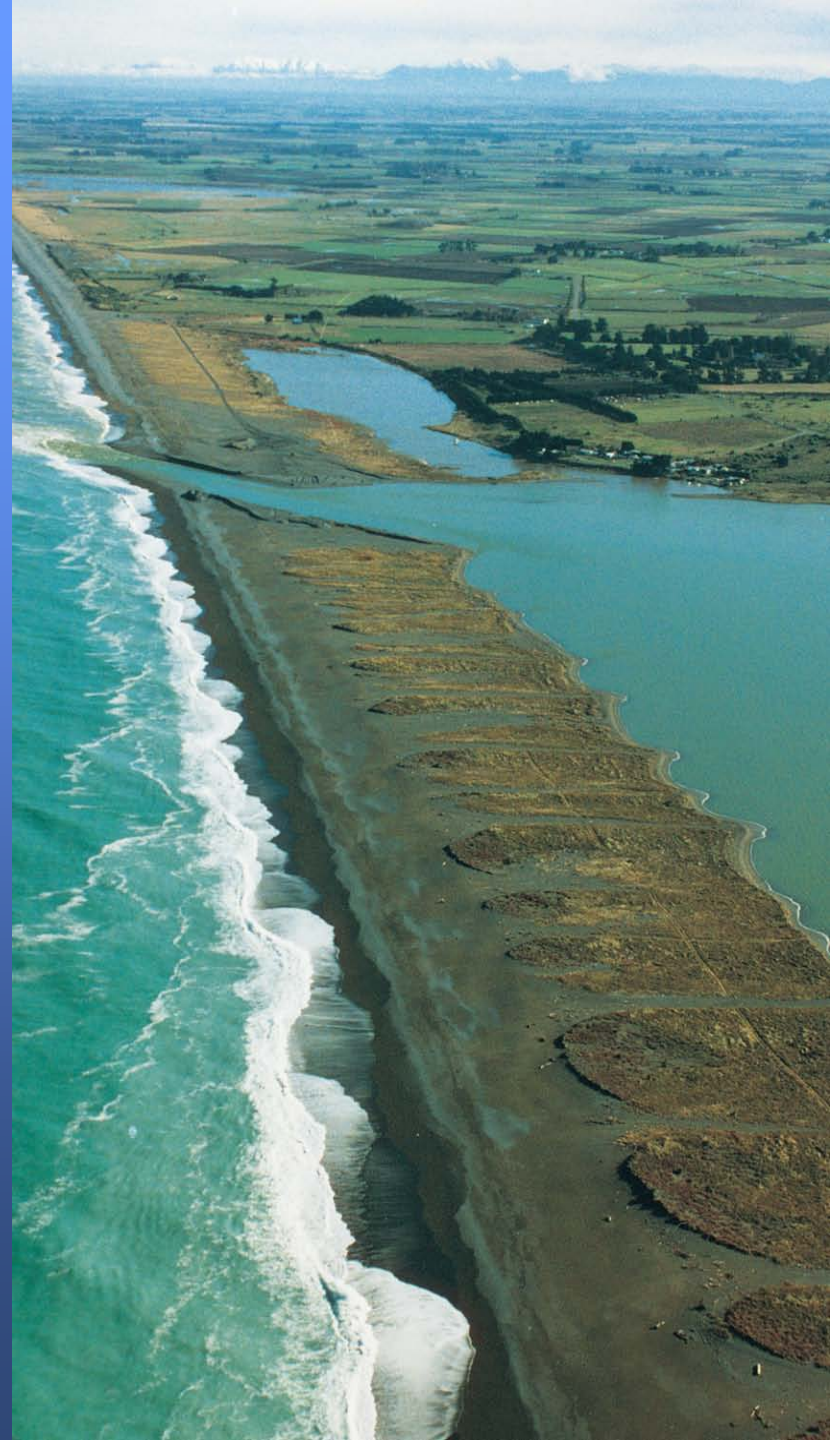
# Lake salinity

Salt – input from the sea during lake openings and from waves overtopping gravel bar

Less frequent lake openings

Decrease in lake salinity

Salinity decreasing

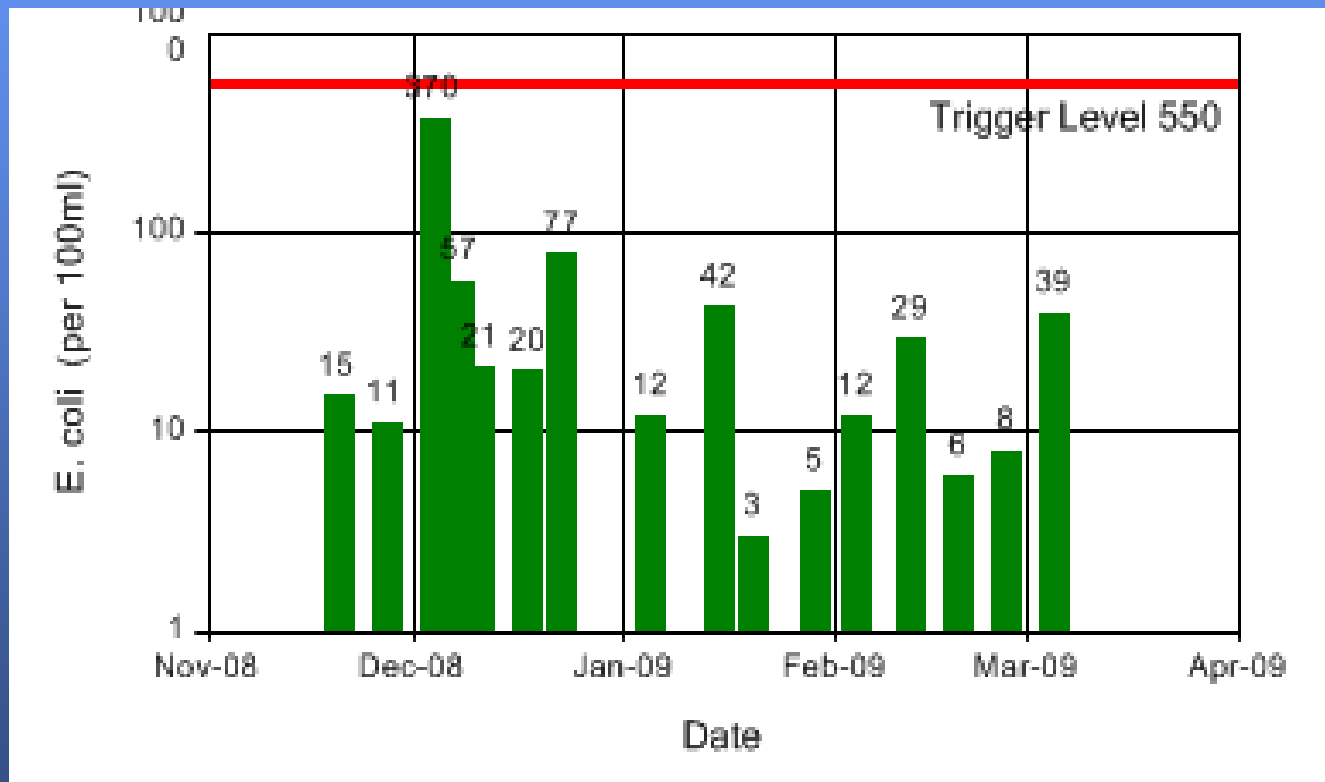
## Lakeside Domain

# Microbial quality

Suitability for recreation grade – fair to good

Microbial quality – improving
